Frequently Asked Questions

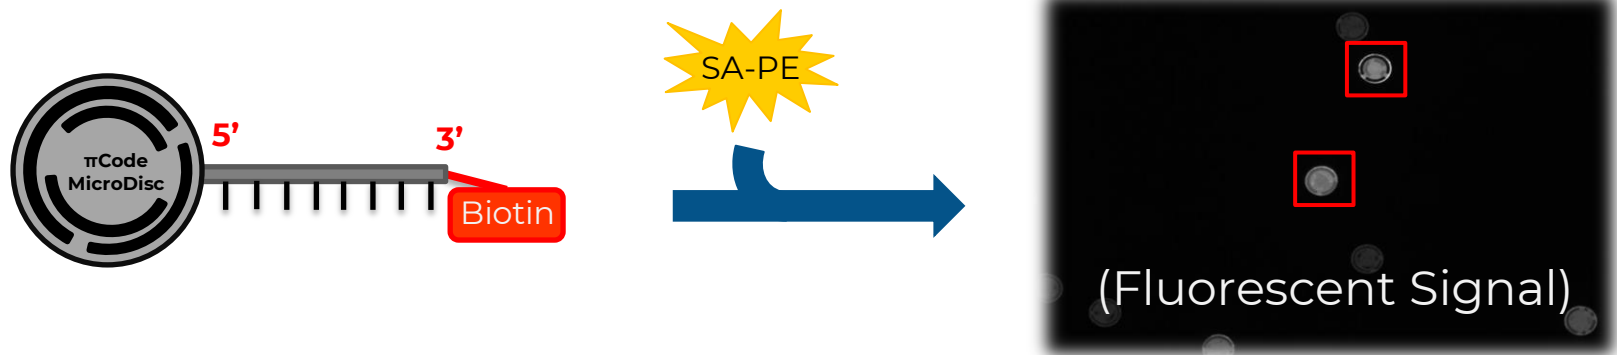
SA-PE control is a biotinylated oligonucleotide coupled to π Code. SA-PE directly binds to the biotin on oligonucleotide and results in fluorescent signal. The SA-PE control monitors the addition of SA-PE solution and the fluorescence intensity, which must be above a certain cut-off to ensure proper performance of the assay.
